Ames Research Center Shear Tests of SLA-561V Heat Shield Material for Mars-Pathfinder

September 1996

This report describes the results of arc-jet testing at Ames Research Center on behalf of Jet Propulsion Laboratory (JPL) for the development of the Mars-Pathfinder heat shield. The current test series evaluated the performance of the ablating SLA-561V heat shield material under shear conditions. In addition, the effectiveness of several methods of repairing damage to the heat shield were evaluated. A total of 26 tests were performed in March 1994 in the 2" × 9" arc-heated Turbulent Duct Facility, including runs to calibrate the facility to obtain the desired shear stress conditions. A total of eleven models were tested. Three different conditions of shear and heating were used. The non-ablating surface shear stresses and the corresponding, approximate, non-ablating surface heating rates were as follows: Condition I, 170 N/m² and 22 W/cm²; Condition II, 240 N/m² and 40 W/cm²; Condition III, 390 N/m² and 51 W/cm². The peak shear stress encountered in flight is represented approximately by Condition I; however, the heating rate was much less than the peak flight value. The peak heat

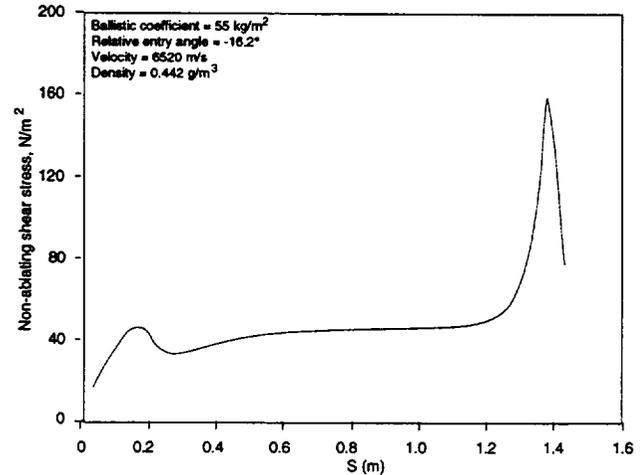
The peak shear stresses on the aeroshell during entry are shown in figure 1; the steepest trajectory under consideration at the present time (-16.2 deg) was assumed. The abscissa, S, is the arc length along the surface from the stagnation point.

The shear stresses were calculated using the GIANTS code, which solves the Navier-Stokes equations over the forebody, neglecting the effects of ablation. Ablation will reduce the surface shear stress below the values shown in figure 1. The assumptions used in the calculations, and the results pertinent to this test series, are shown in table 1. The trajectory parameters were arrived at jointly by ARC and JPL in February 1994.

Figure 1. Non-ablating shear stress distribution over Mars-Pathfinder forebody.

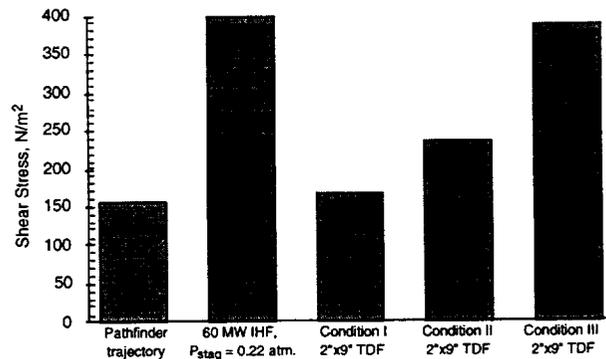
the trajectory described above. Three shear levels were chosen for this test series, as summarized in table 2. Condition I represents a value about 10 percent higher than the maximum shear stress predicted for the flight case shown in figure 1. Test Condition II represents an intermediate level between Conditions I and III. Test Condition III reproduces the shear condition encountered during previous tests in arc 60 MW IHF. The IHF tests produced heating rates and stagnation pressures appropriate for the vehicle's stagnation point (approximately 100 W/cm² and 0.22 atm). However, the stagnation point models produced unrealistically high shear stresses on the model corners, and correspondingly high rates of erosion. Test Condition III of the current series was chosen to check the ablator's performance for consistency with the previous test results. In addition, Condition III comes closest to reproducing the peak flight heating rate at the body location where the maximum shear stress occurs.

Figure 2. Comparisons of flight and test peak shear stresses.

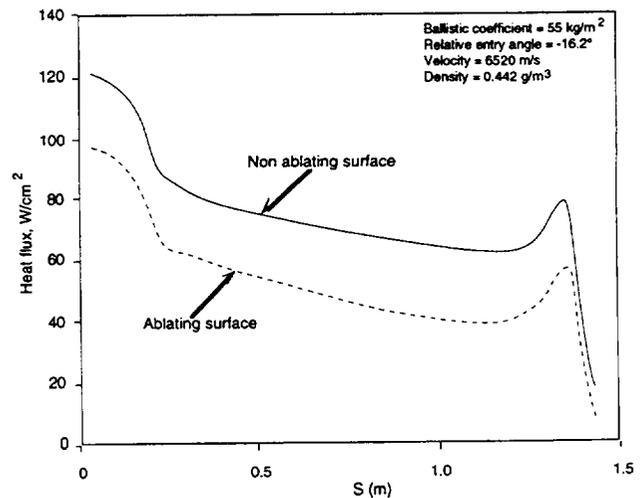
The shear stresses shown in table 2 were the most significant test parameter; the heating rates are the product of the corresponding arc-jet settings. The shear and heating rate values shown represent peak test conditions, and do not include the variations associated with starting and shutting down the test facility. While it is impossible to match both the peak shear and heating rate in the facility to the flight levels, the total heat load was approximately matched by varying the test duration. The exposure times were selected to match the total (non-ablating) heat load at the body location of maximum shear stress. Figure 2 compares the non-ablating shear stresses used during this test program with those predicted for the Mars-Pathfinder trajectory, and those of the earlier 60 MW IHF tests. Figure 3 shows the non-ablating surface heating rates for the same flight trajectory.

Figure 3. Pathfinder heating rate distribution.

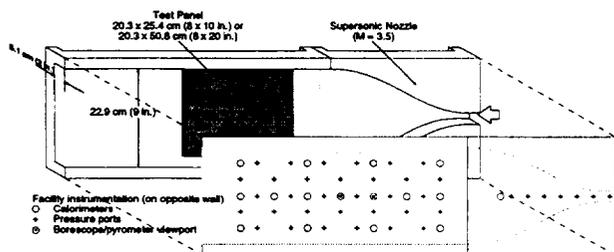
The 2" x 9" arc-heated Turbulent Flow Duct Facility is a supersonic blow-down type wind tunnel using an electric arc heater and capable of continuous operation within power supply limit. Presently in use is a Linde type arc heater that can produce stream enthalpies up to 5.8 MJ/kg (2500 BTU/lb) and maximum free stream Mach number of 3.5. The test gas (air in this case) is heated by an electrical discharge and the supersonic flow is then expanded into a test chamber through a two-dimensional nozzle exit. The test chamber, shown schematically in figure 4, is a water-cooled rectangular structure made of copper side and end plates bolted together to form a 5 cm x 23 cm (2" x 9") test section. The test panel is mounted flush on the test section's widest side, and the wall opposite the test section is instrumented with pressure ports and flush-mounted calorimeters. Unlike the 60 MW IHF, where the model is mounted on a moveable sting, the test model is exposed to the flow from start up until the facility is shut down. This fact is important because the starting transient can be a large fraction of the model's exposure time to the stream.

Figure 4. 2" x 9" arc-heated Turbulent Duct Facility test section.

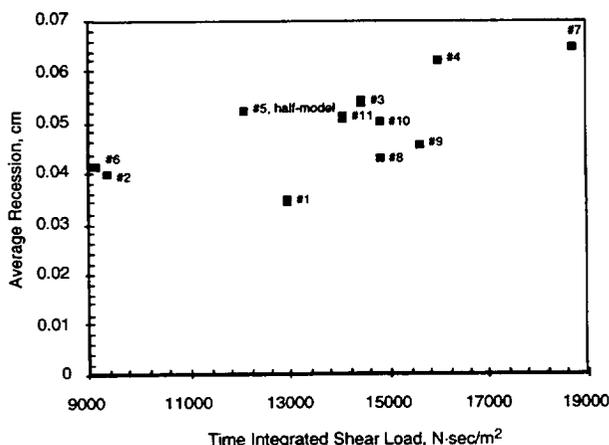
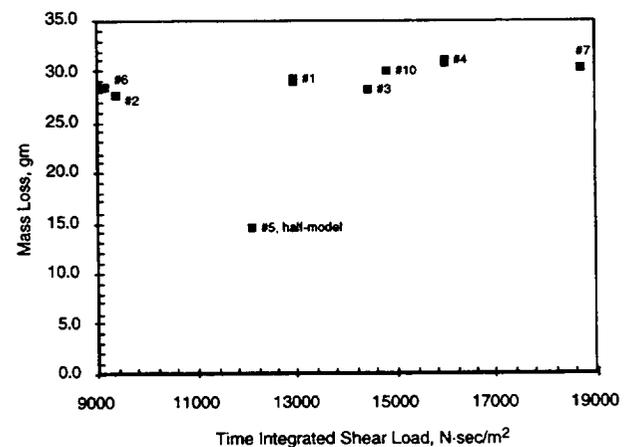
Figures 5(a) and (b) show the average recession and total mass loss as a function of the integrated shear load. Although the scatter in the data approached ± 15 percent, the recession trend is a fairly smooth function of the integrated shear load. The low average surface recession of model #1 is likely the result of the low heating rate; however, the temperatures were high enough to cause the resin to pyrolyze sufficiently to produce a mass loss comparable to that of the other models. No anomalous mass removal is evident from figure 5(b). Note that the mass loss measurements from the three models with repair plugs (#8, #9, and #11) were deliberately excluded from figure 5(b), to avoid mixing mass loss from the repair materials with that from the heat shield material.

Figure 5. (a) Average recession vs. integrated shear load, (b) total mass loss vs. integrated shear load.

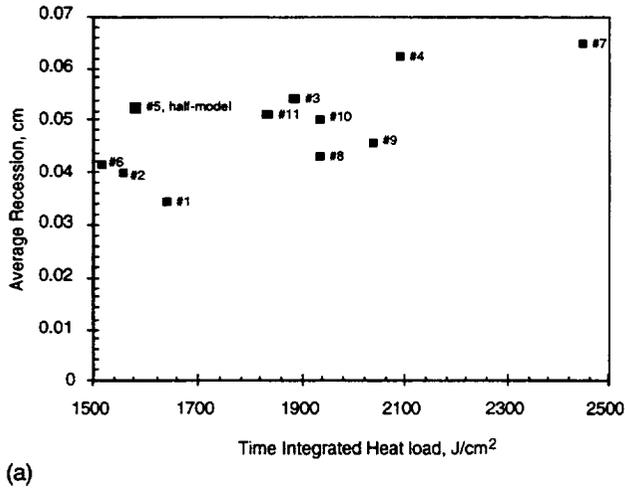
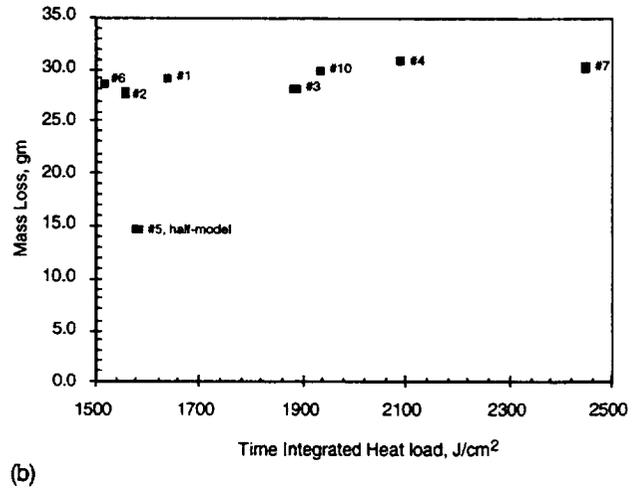
hear stress multiplied by the time at test conditions. Figure 6(a) shows the total variation of mass loss with the integrated shear load, and figure 6(b) shows the total mass loss as a function of heat load. The results shown in figures 6(a) and (b) are very similar to those illustrated and discussed previously in figures 5(a) and (b). As explained above for figure 5(b), the data from the repair models were excluded from the mass loss data shown in figure 6(b). Visual inspection of the models' surfaces showed well-adhered char layers. No excessive surface erosion, spallation or uneven melting were detected. On the models tested at Condition III, small droplets condensed on the phenolic honeycomb structure, indicating that some melting had occurred.

Figure 6. (a) Average recession vs. integrated heat load, (b) total mass loss vs. integrated heat load.

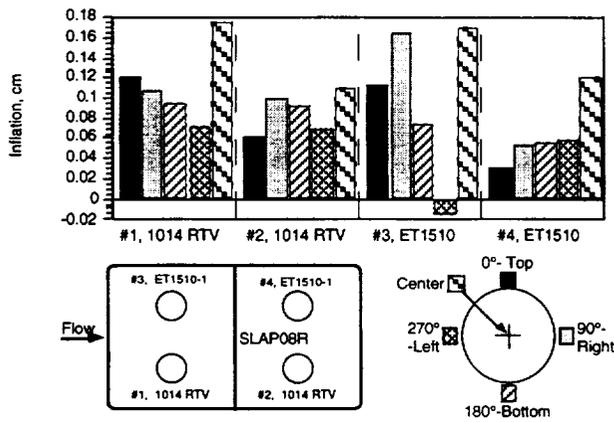
approximately 9 cells (3 × 3 cells). A filled gap, 0.076 cm wide, ran completely across the model perpendicular to the flow. All four plugs experienced cracking; this was most extensive on plugs #2 and #3. A significant amount of material was removed by spallation and vaporization, and large cracks appeared on these two repair plugs. The surfaces of all plugs inflated (rose above the surrounding surface) to an average of about 0.13 cm; the inflation is plotted in figure 7. The gap filler material melted, forming a forward-facing step to the flow. This step increased the local heating and material erosion near the center of the model.

Figure 7. Surface inflation measurements around repairs on model SLAP08R.

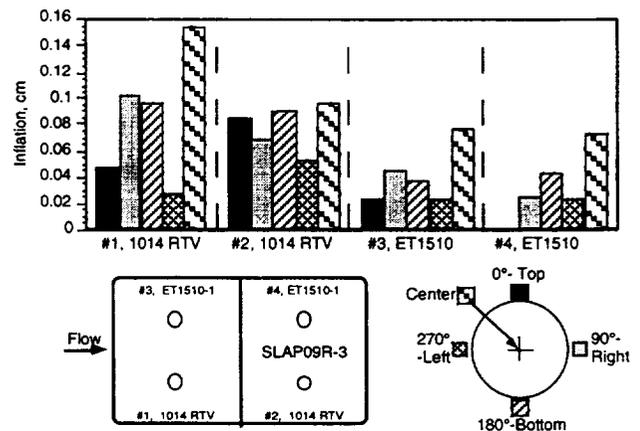
approximately 4 cells (2 × 2 cells). It also had a gap, described by Lockheed-Martin-Michoud as a “standard bondline” gap, running perpendicular to the flow. This gap, nominally 0.013 cm wide, performed very well; no significant enlargement, melting, or erosion was observed. As in the SLAP08R model, all four repair plugs experienced cracking and inflation. However, as figure 8 shows, repair plugs #1 and #3 (the upstream plugs) experienced more inflation than plugs #2 and #4 (the downstream plugs).

Figure 8. Surface inflation measurements around repairs on model SLAP09R.

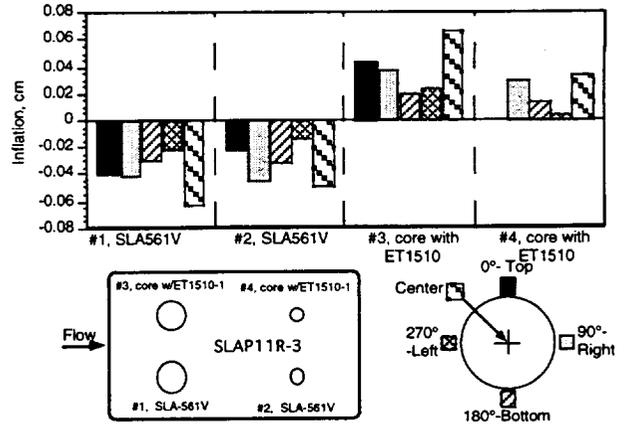
SLAP11R– This model, illustrated on page 21 of Appendix A, had four repair plugs. The two upstream repairs covered approximately 9 cells (3 × 3) and the other two covered approximately 4 cells (2 × 2). The repair plugs #1 and #2, shown on the left in the figure, were made of SLA-561V, including the honeycomb reinforcement, bonded with GX-6300. These plugs performed well, recessing 0.05 cm, and no cracking was observed. The downstream repair (plug #2) did not perform as well as the upstream repair plug, however, because the inserted core fit poorly into the opening. Repair plugs #3 and #4, shown on the right in the figure, had honeycomb cores hand-packed with ET1510-I resin. These repair plugs experienced some cracking and inflation. Cell size did not seem to have a significant impact on the repair performance. Figure 9 shows that repair plugs filled with ET1510-I inflated about 0.038 cm.

Figure 9. Surface recession measurements around repairs on model SLAP11R.

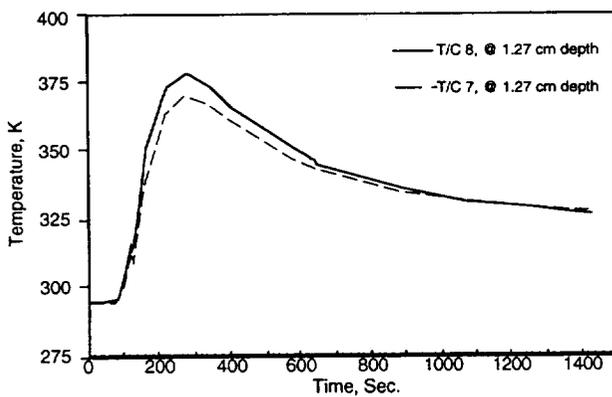
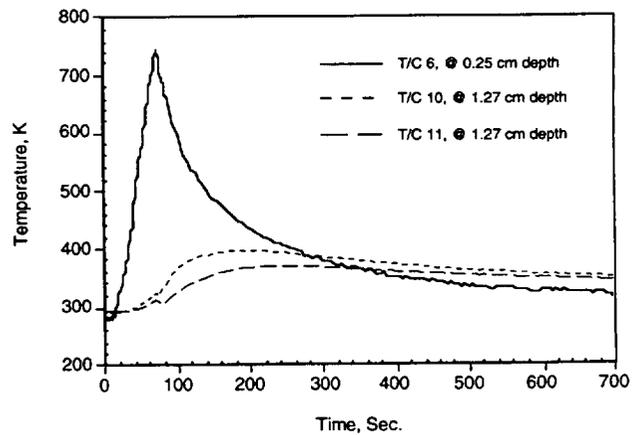
thermocouples were connected to a strip chart recorder. Thirty-one thermocouples, or about 70 percent, produced usable data. The figures in Appendix A (pages 15–17) show the location and depth of each model’s thermocouples. Figures 10(a) and (b) show the in-depth temperature response after 31 sec of exposures to Condition III, while figures 11(a) and (b) show a typical response after 48 sec of exposure. The temperatures indicated in figures 10(a) and (b) are smooth, while those in figures 11(a) and (b) show some noise. The 5 to 7 percent variation in the peak temperatures recorded by the gages installed 0.25 cm below the surface probably reflects primarily the variation of heating rate over the model.

Figure 10. (a) In-depth temperature response to 31 sec exposure, from model SLAP05TC-3, (b) in-depth temperature response to 31 sec exposure, from model SLAP05TC-3.

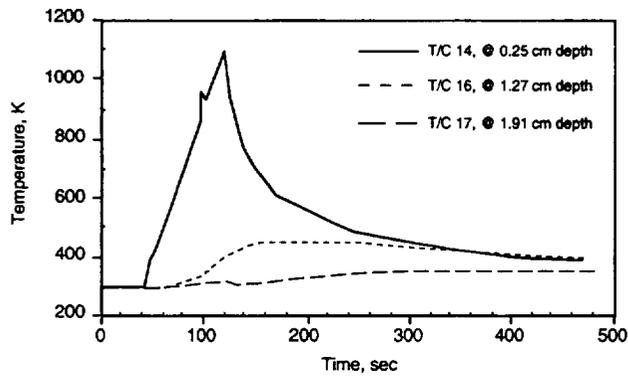
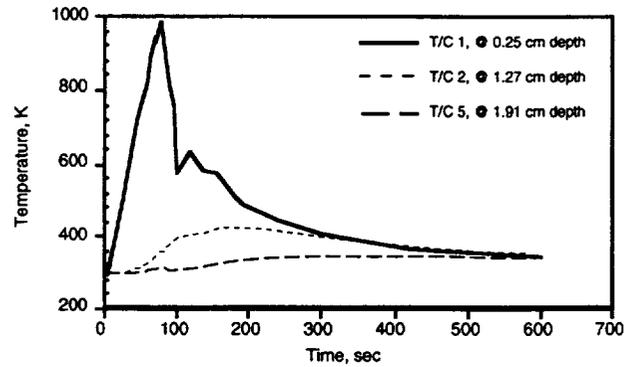
Figure 11. (a) In-depth temperature response to 48 sec exposure, from model SLAP07TC-3, (b) in-depth temperature response to 48 sec exposure, from model SLAP07TC-3.

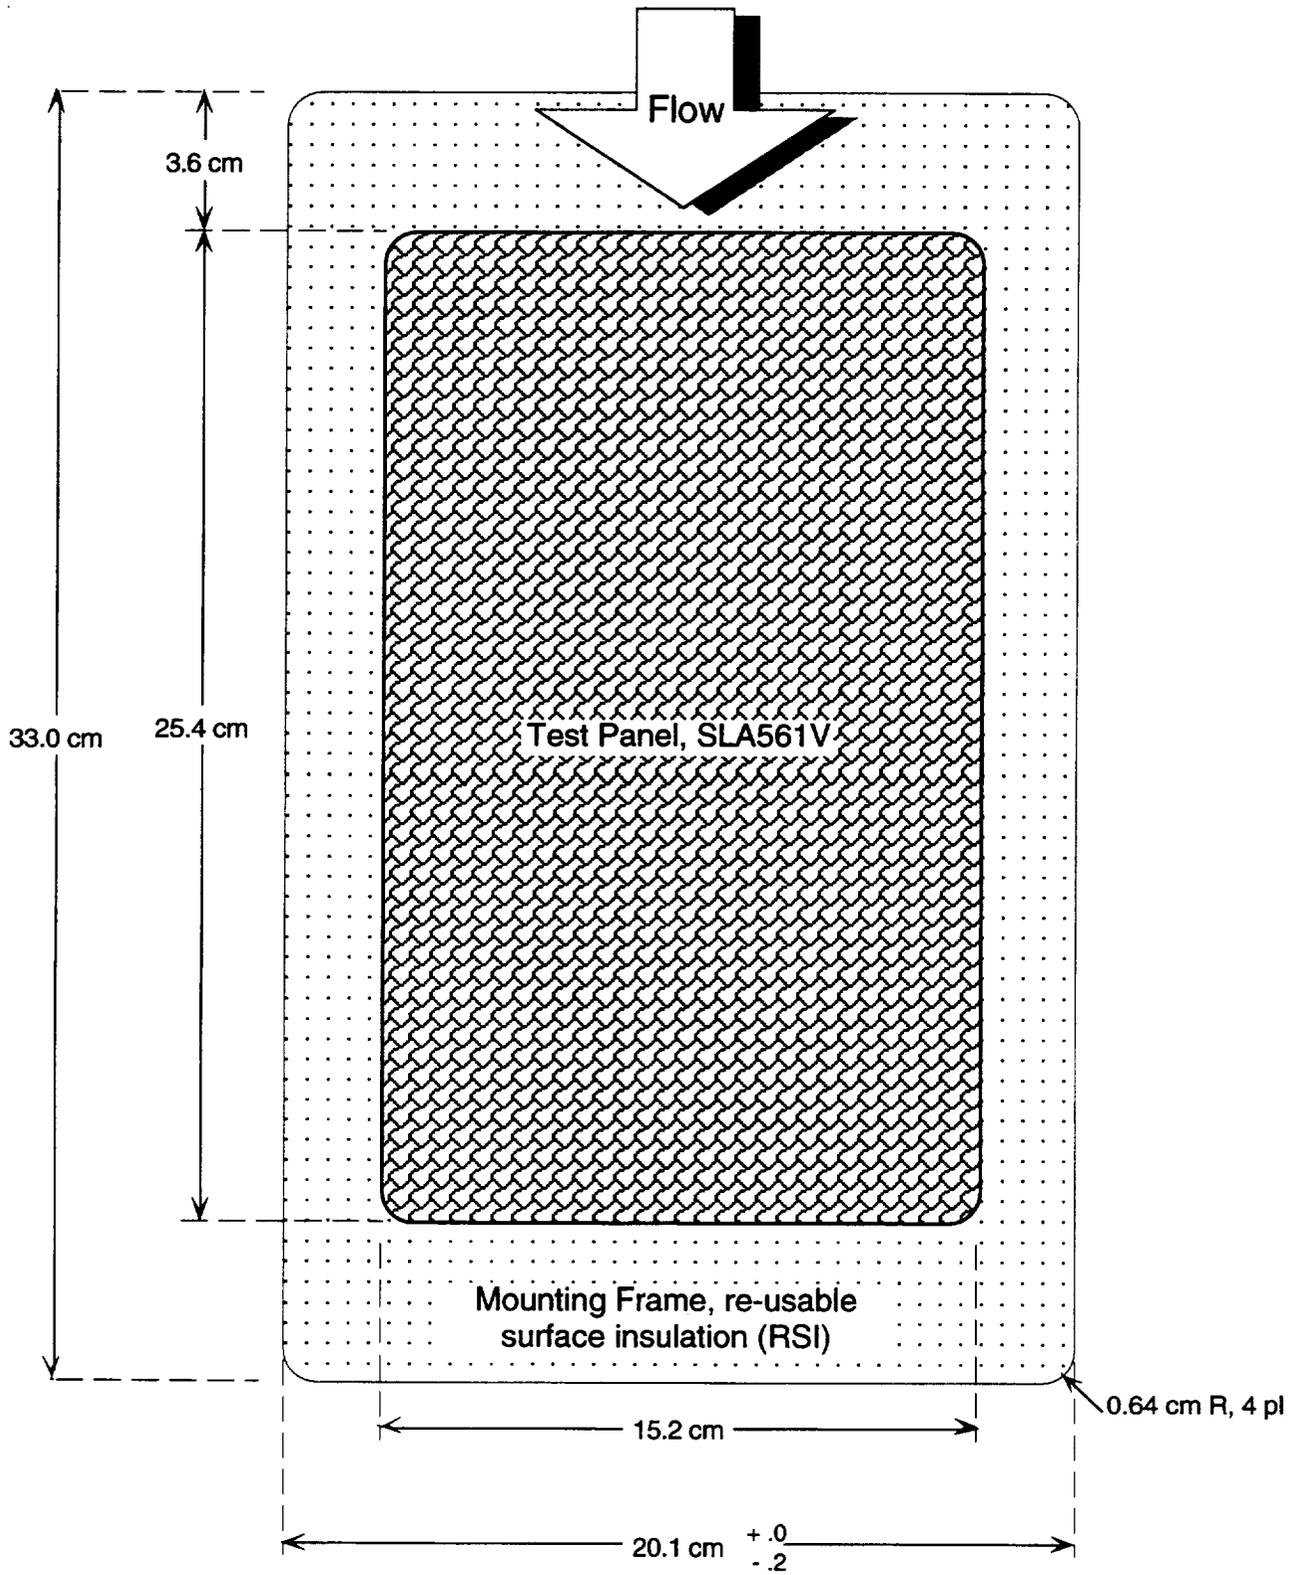
Figure A-1. Schematic of models SLAP01, SLAP02, SLAP03, and SLAP04.

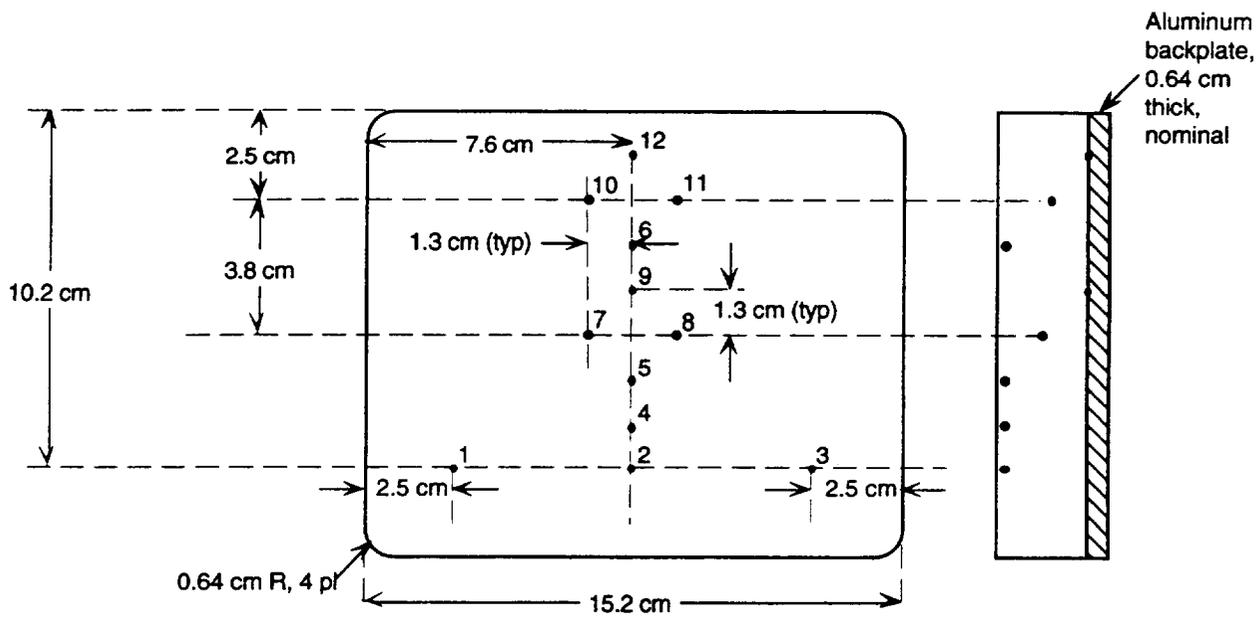
Thermocouple depth
beneath surface

#	cm	#	cm
1	0.25	7	1.3
2	0.25	8	1.3
3	0.25	9	2.5
4	0.25	10	1.3
5	0.25	11	1.3
6	0.25	12	2.5

Figure A-2. Schematic of model SLAP05.

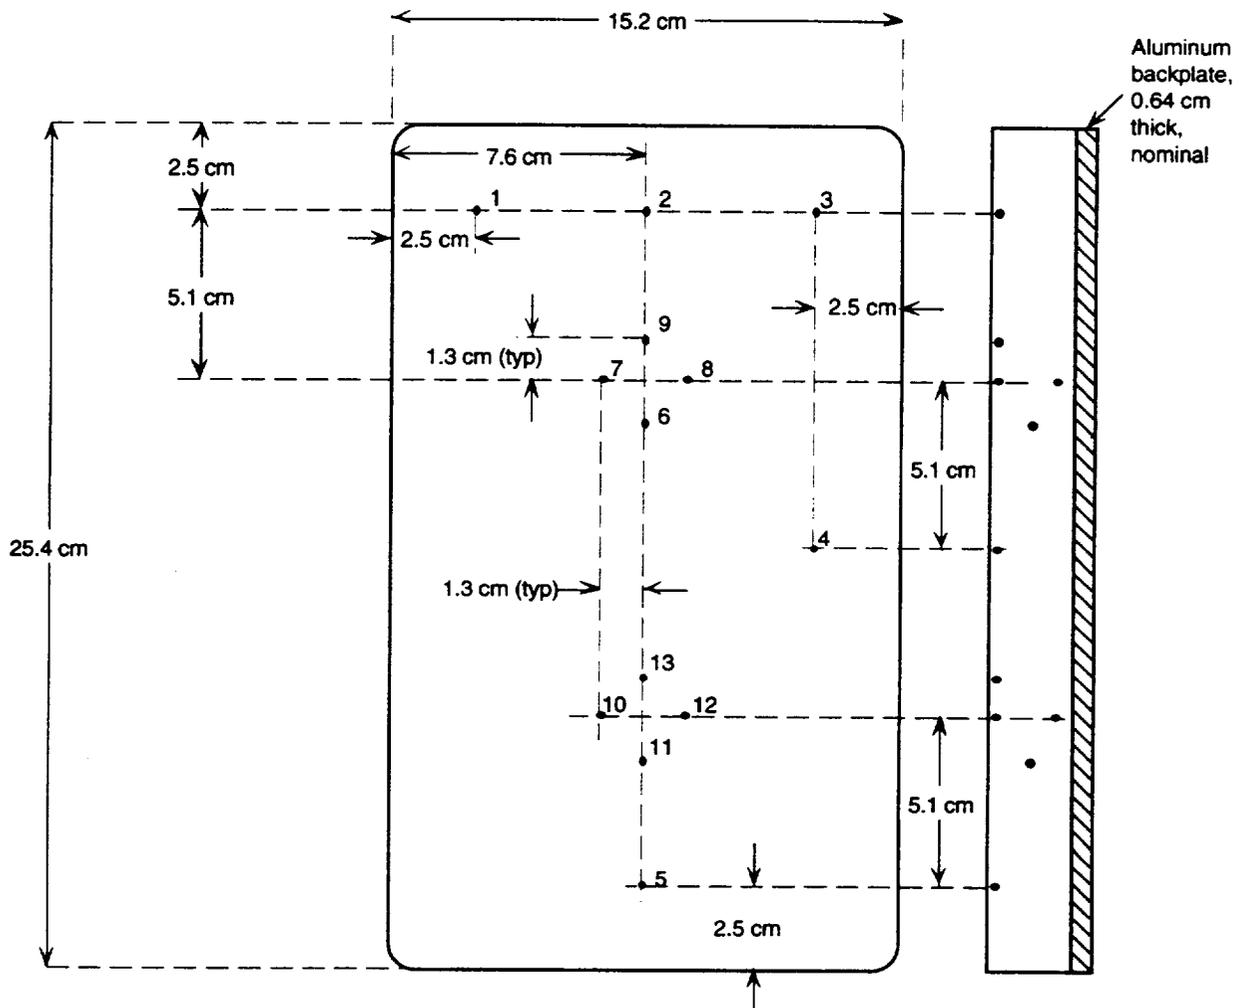
Thermocouple depth beneath surface

#	cm	#	cm
1	0.25	7	0.25
2	0.25	8	1.9
3	0.25	9	0.25
4	0.25	10	0.25
5	0.25	11	1.3
6	1.3	12	1.9
		13	0.25

Figure A-3. Schematic of model SLAP06.

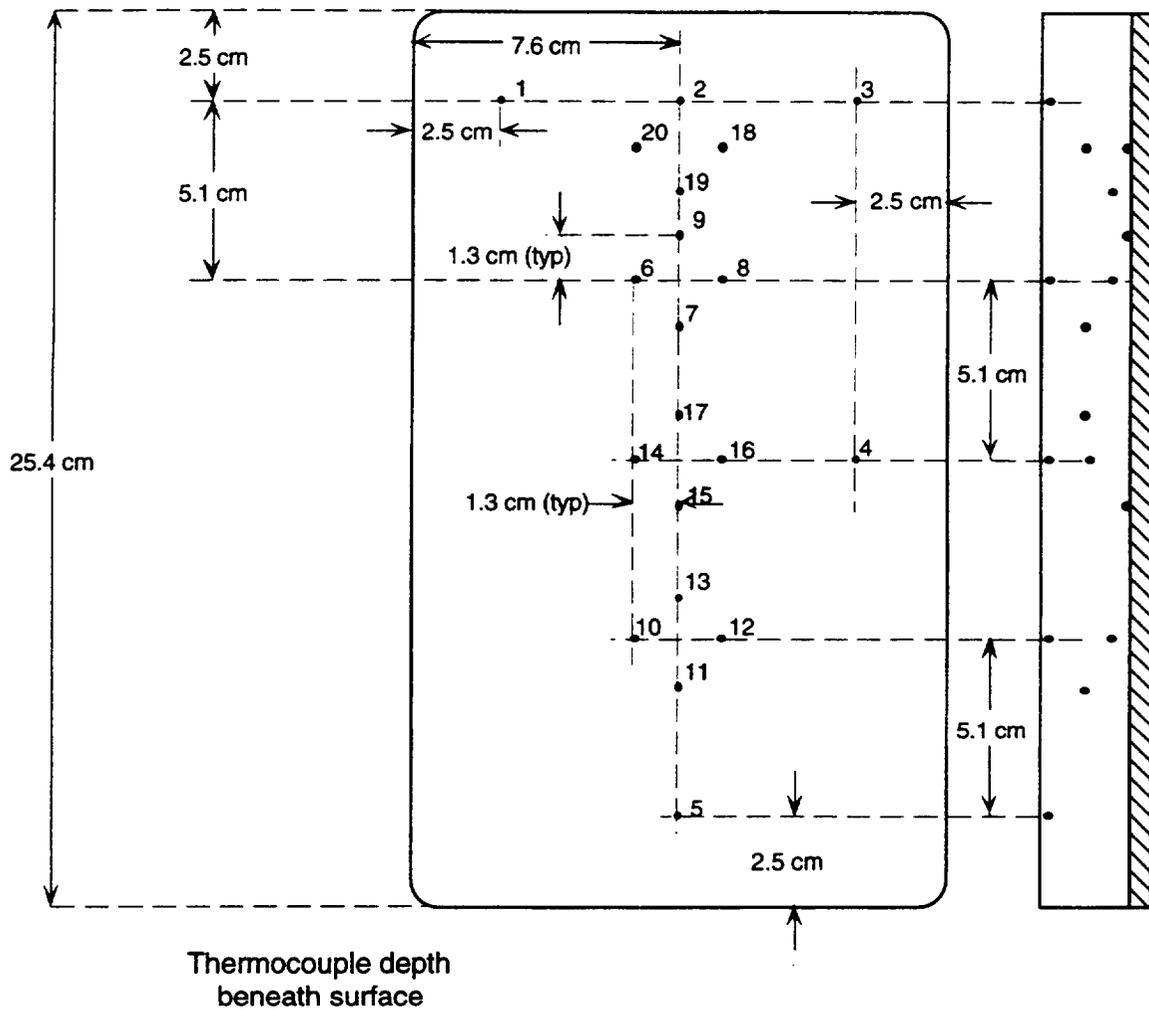
#	cm	#	cm
1	0.25	11	1.3
2	0.25	12	1.9
3	0.25	13	2.5
4	0.25	14	0.25
5	0.25	15	2.5
6	0.25	16	1.9
7	1.3	17	1.3
8	1.9	18	1.3
9	0.25	19	1.9
10	0.25	20	2.5

Figure A-4. Schematic of model SLAP07.

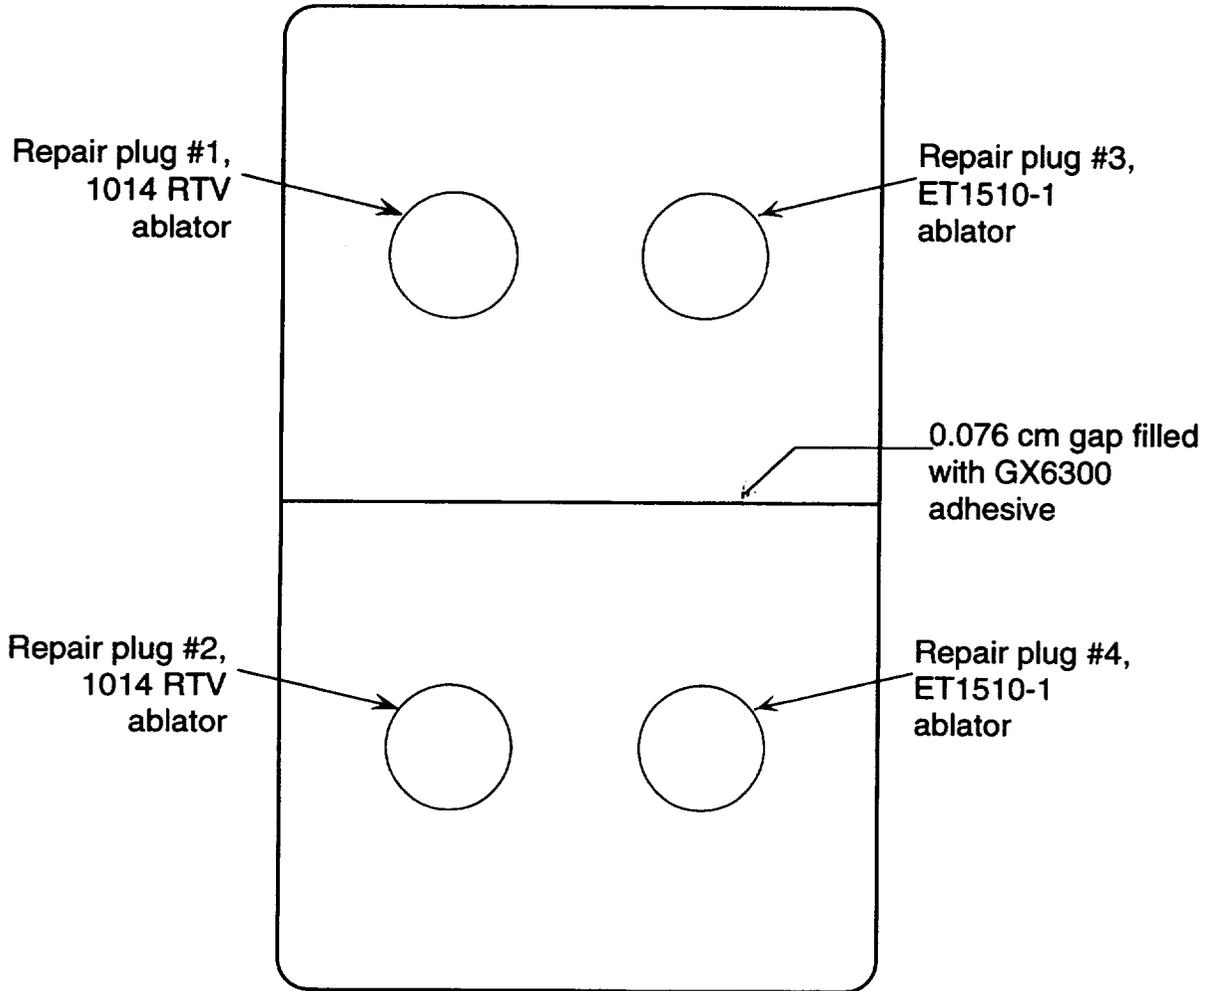
Repairs on this panel are approximately 3.3 cm in diameter; approximately 3x3 honeycomb cells.

Figure A-5. Schematic of model SLAP08.

SLAP08R-3— This model, illustrated on page 18 of Appendix A, had four repair plugs, each covering

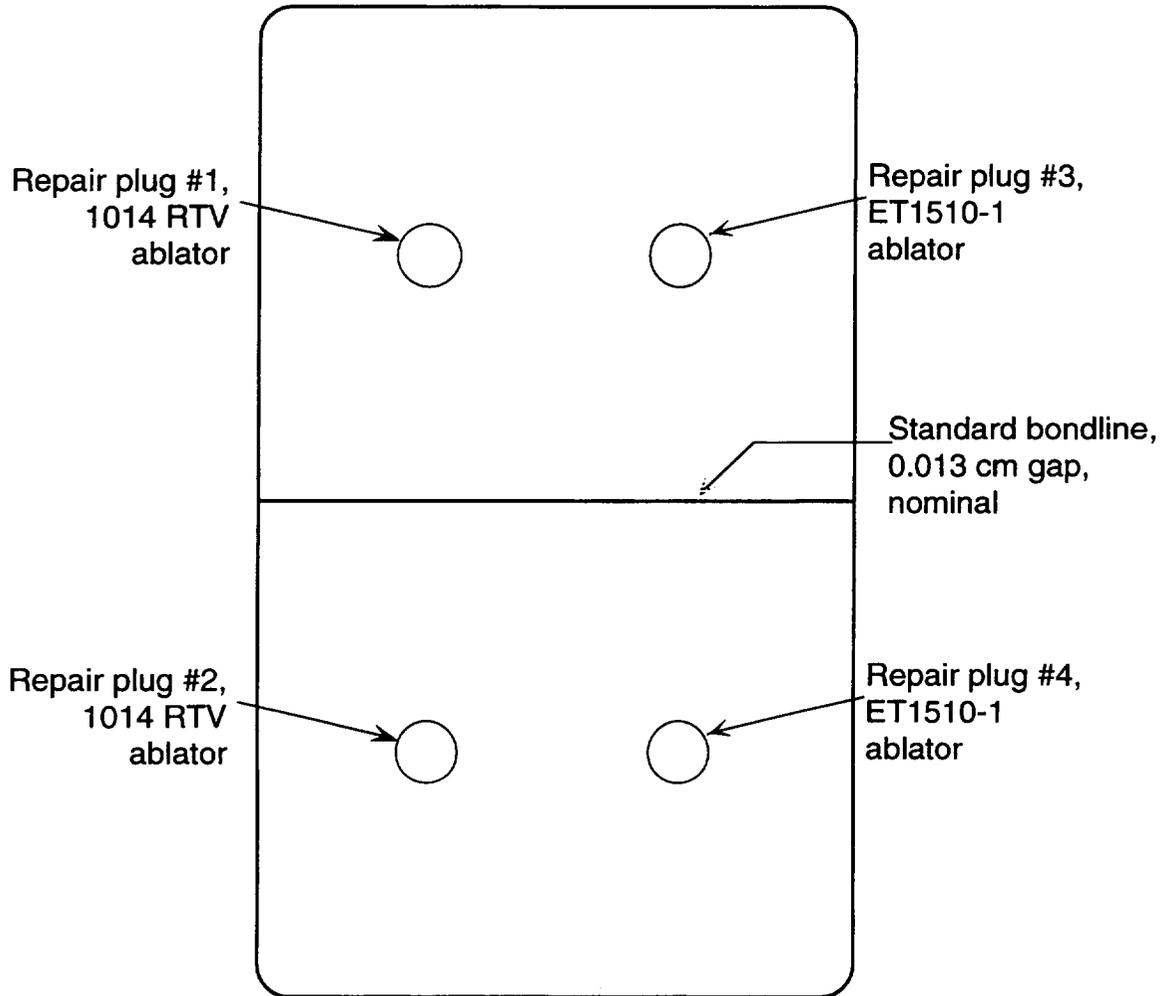
Repairs on this panel are approximately 1.5 cm in diameter; approximately 2x2 honeycomb cells.

Figure A-6. Schematic of model SLAP09.

SLAP09R– This model, illustrated on page 19 of Appendix A, had four repair plugs, each covering

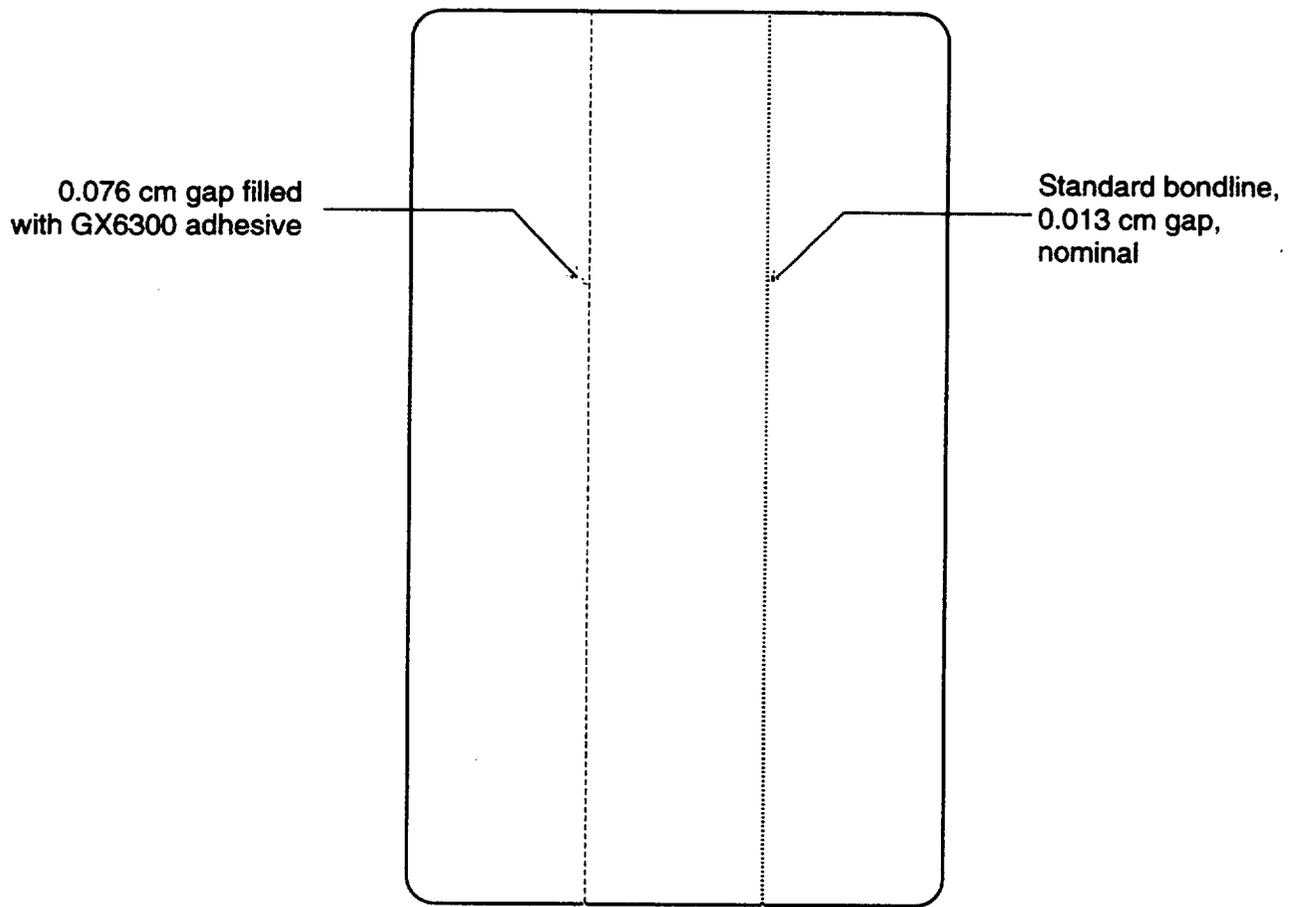
Figure A-7. Schematic of model SLAP10.

SLAP10R– This model, illustrated on page 20 of Appendix A, had two gaps running the length of the model, parallel to the flow direction. One was a standard bondline gap and the other was a 0.076 cm wide gap filled

with GX-6300 resin. As in the prior test, the standard bondline was essentially unaffected by the hot gas. The 0.076 cm gap was widened by flow penetration and melt run-off was observed near the gap surface. Unlike the SLAP08R model, surface erosion or material depletion was not increased.

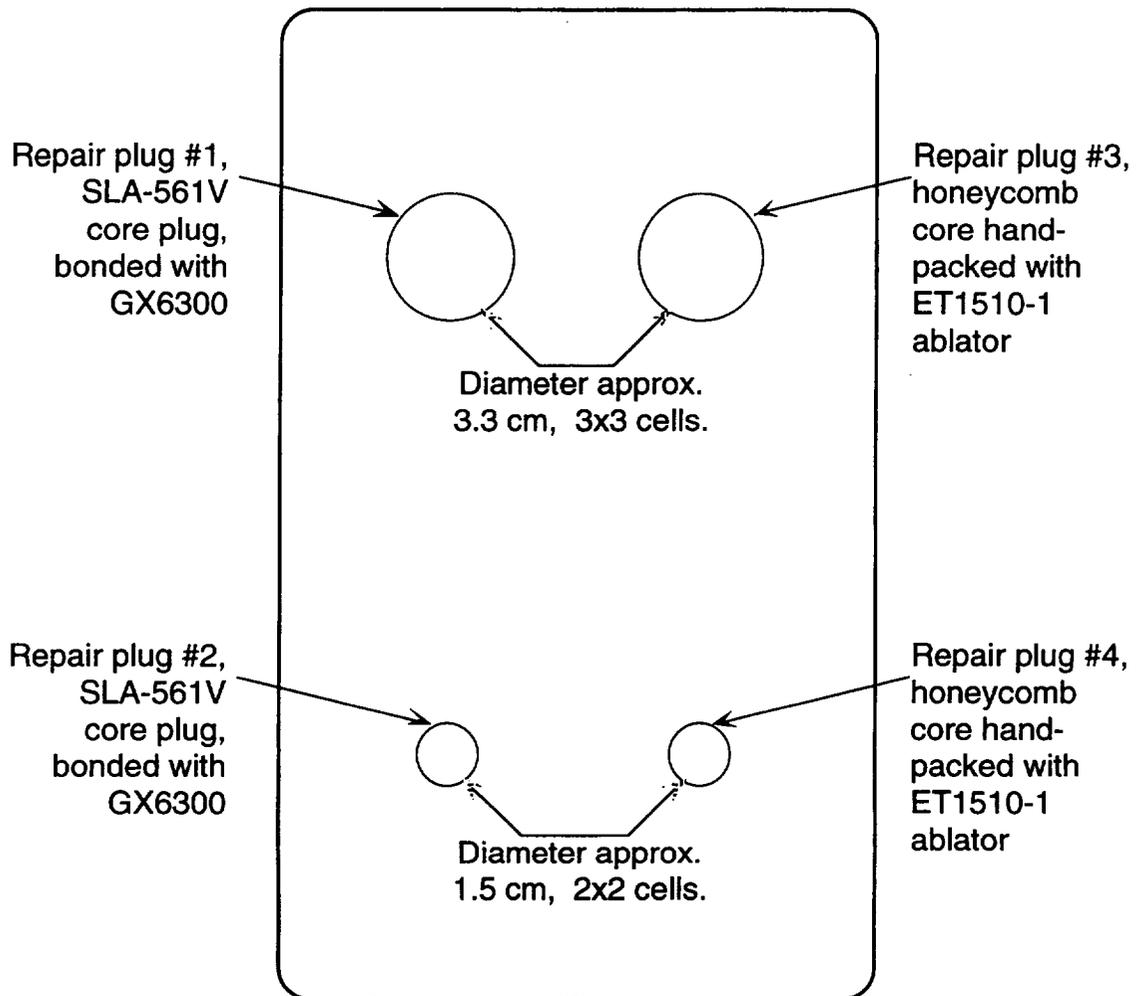
Figure A-8. Schematic of model SLAP11.

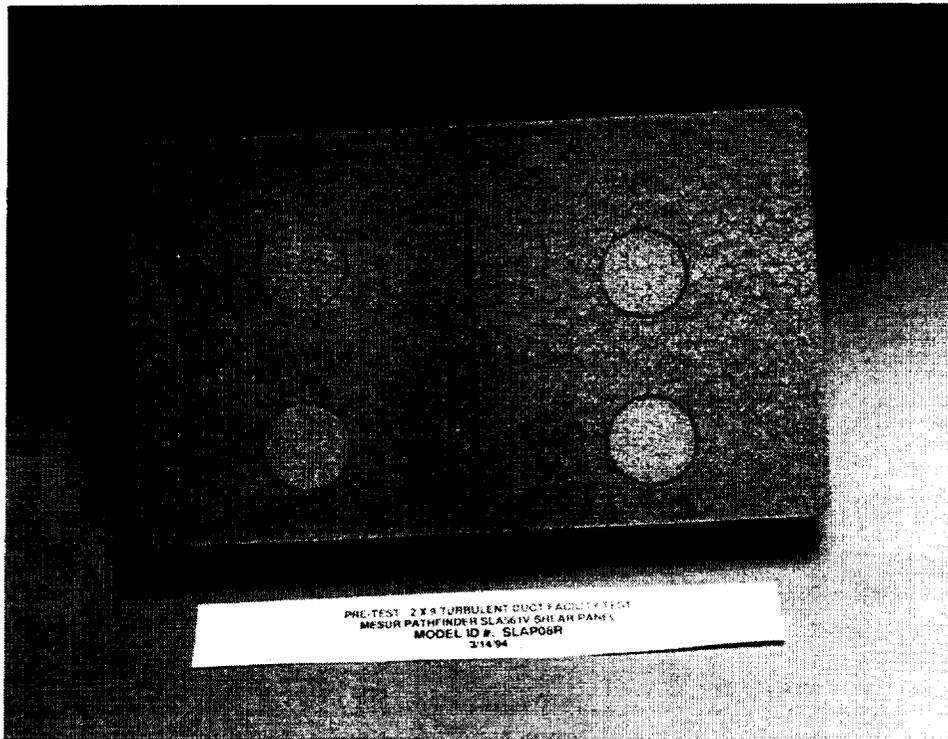
Figure A-16. Pre- and post-test photos of model SLAP08R-3. (a) Repair plug and gap model SLAP08R-3, (b) SLAP08R-3 after 38 sec @ $\tau = 390 \text{ N/m}^2$, $\dot{q} = 51 \text{ W/cm}^2$.

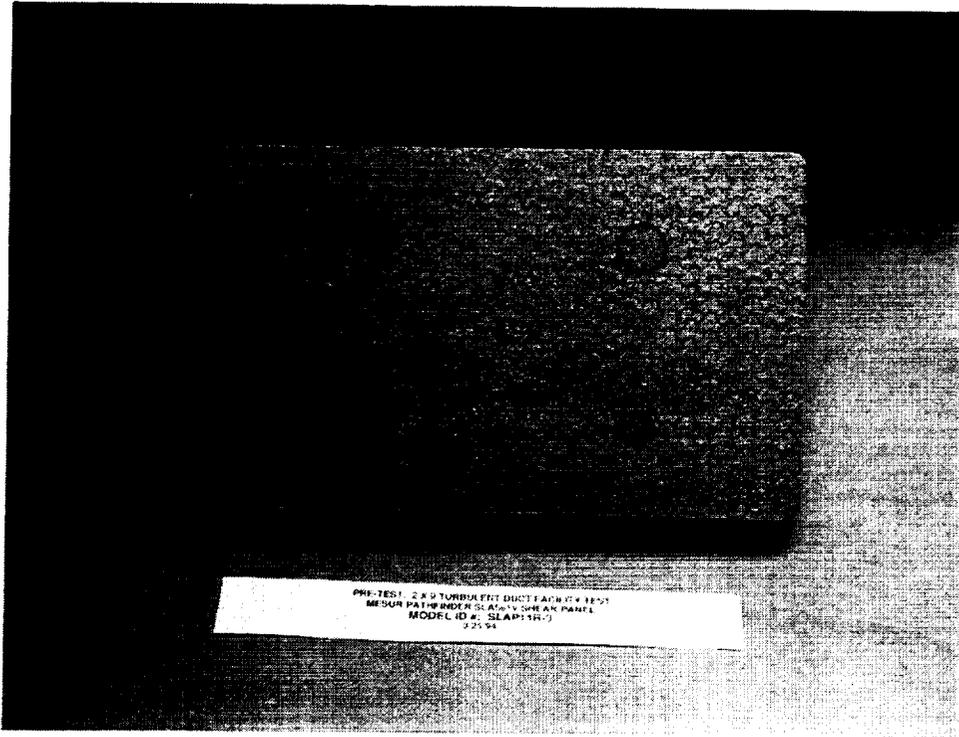
Figure A-19. Pre- and post-test photos of model SLAP11R-3. (a) Repair plug model SLAP11R-3, (b) SLAP11R-3 after 36 sec @ $\tau = 390 \text{ N/m}^2$, $\dot{q} = 51 \text{ W/cm}^2$.

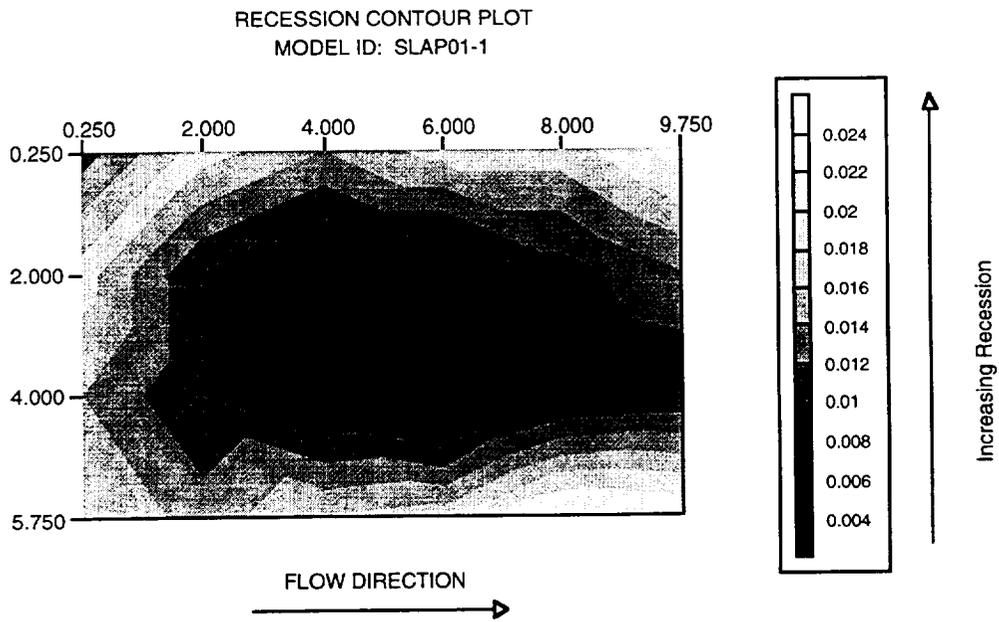
Panel: 6 in. Width
10 in. Length
1 in. Height
Unit: Inches

Figure A-20. Recession contour plots of model SLAP01-1.

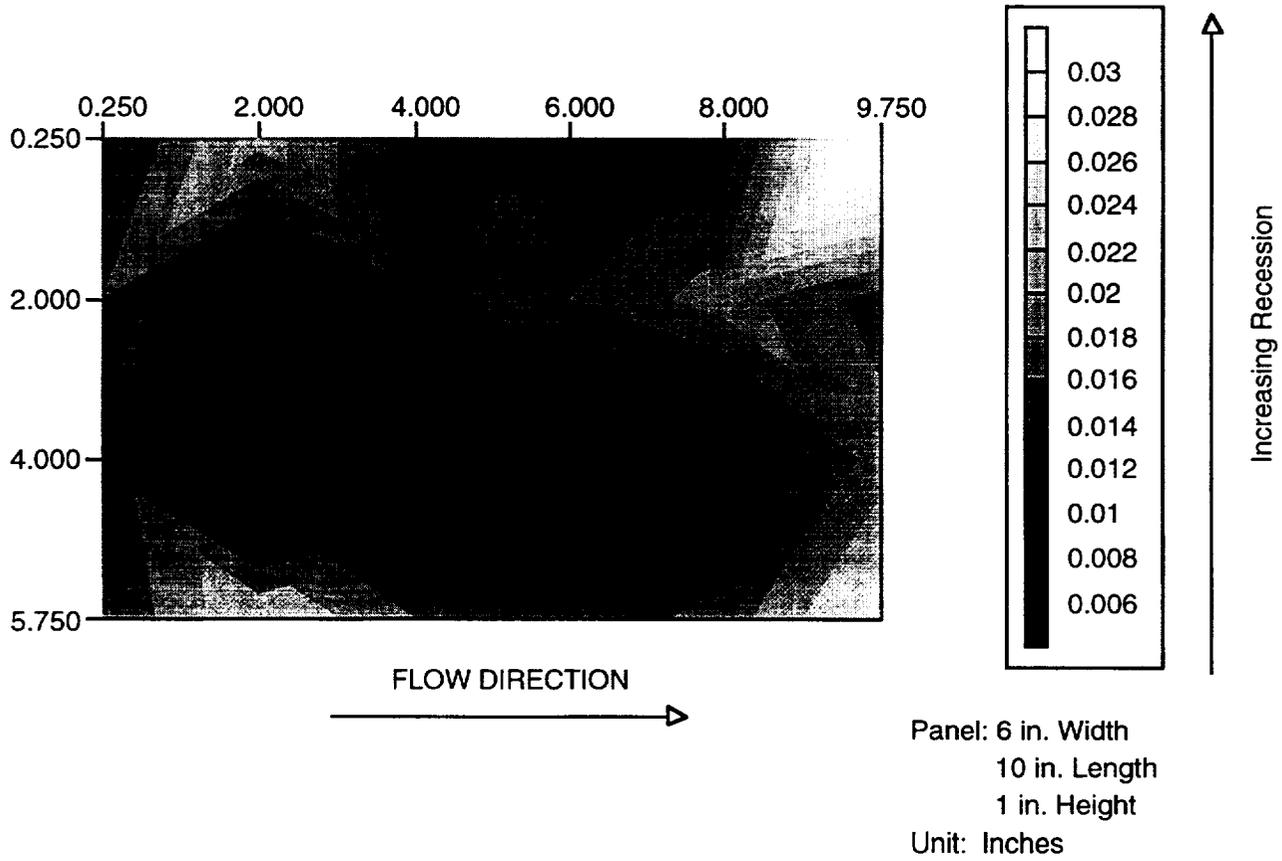
RECESSION CONTOUR PLOT
MODEL ID: SLAP02-2

Figure A-21. Recession contour plots of model SLAP02-2.

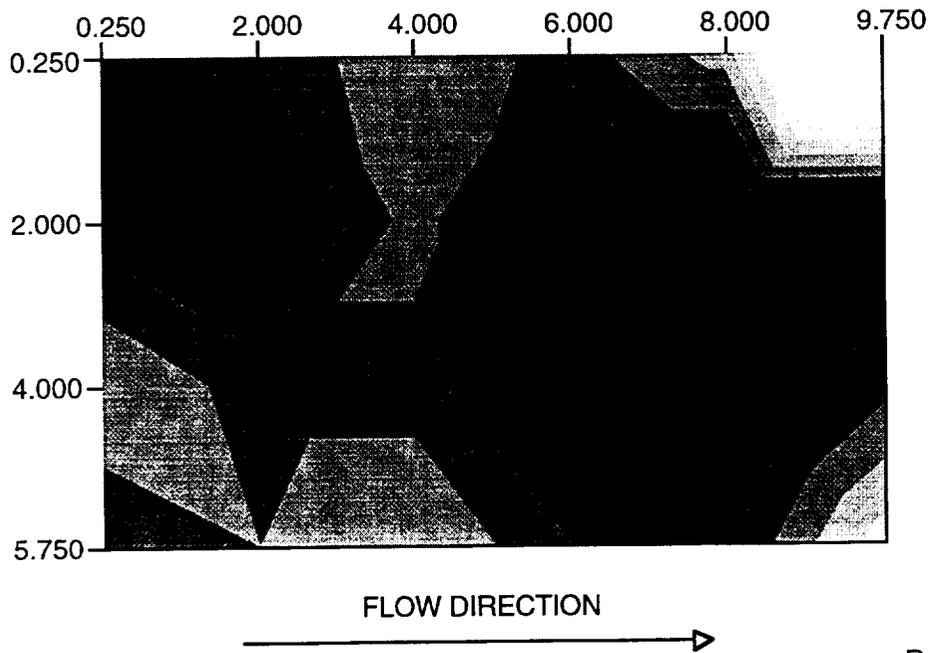
RECESSION CONTOUR PLOT
MODEL ID: SLAP03-3

Figure A-22. Recession contour plots of model SLAP03-3.

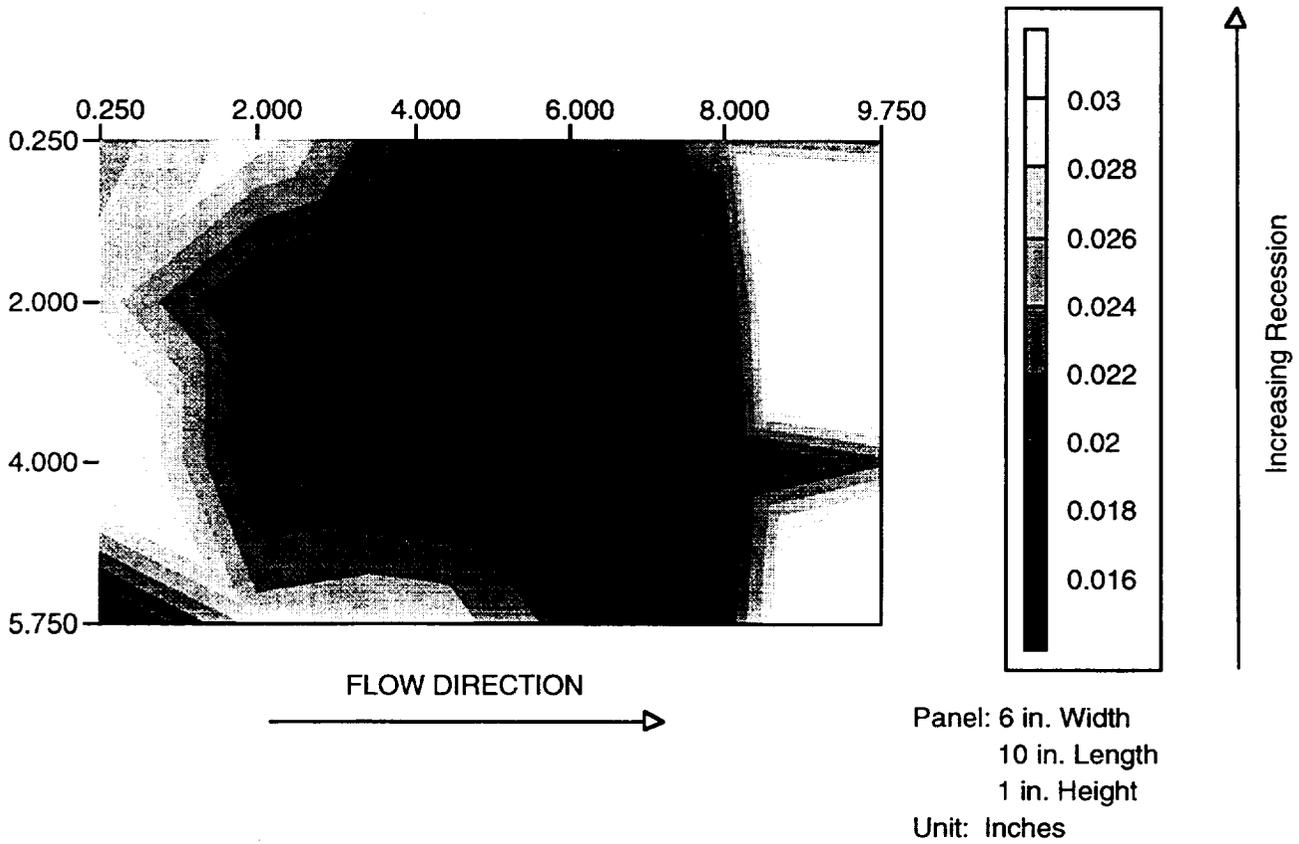
RECESSION CONTOUR PLOT
MODEL ID: SLAP04-3

Figure A-23. Recession contour plots of model SLAP04-3.

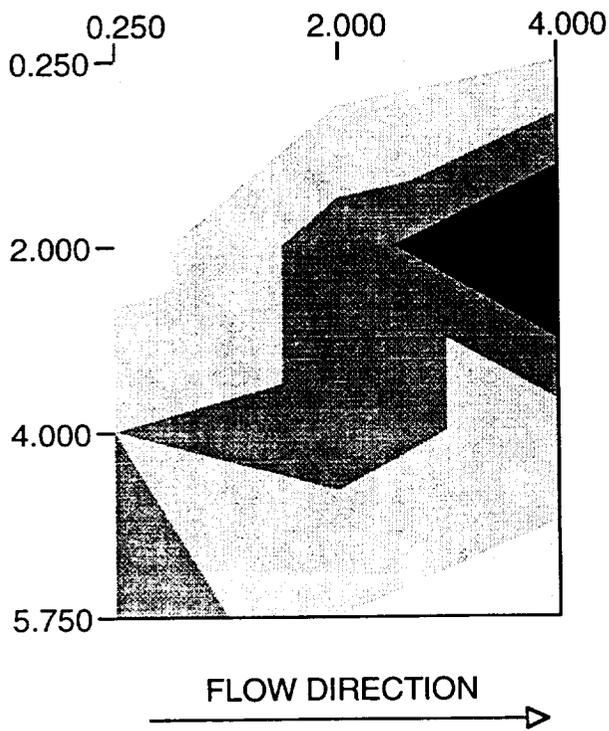
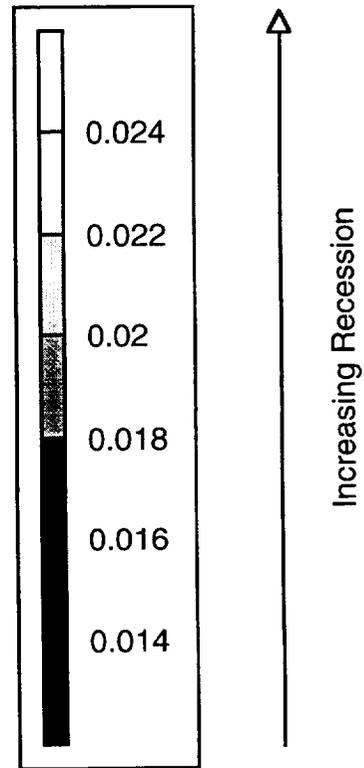
RECESSION CONTOUR PLOT
MODEL ID: SLAP05TC-3

Figure A-24. Recession contour plots of model SLAP05TC-3.
